Hardline Laboratory

Report No. : YA30070/2023

Product Description: Hockey Puck Padlock  
Manufacturer/Vendor: One Lus International Co., Ltd.  
Country of Origin: Taiwan

Test Requested: Loading test

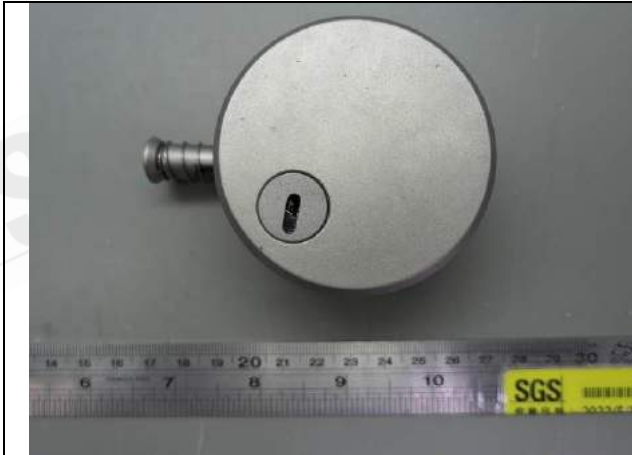
Photo "A" Appearance of sample (front view)

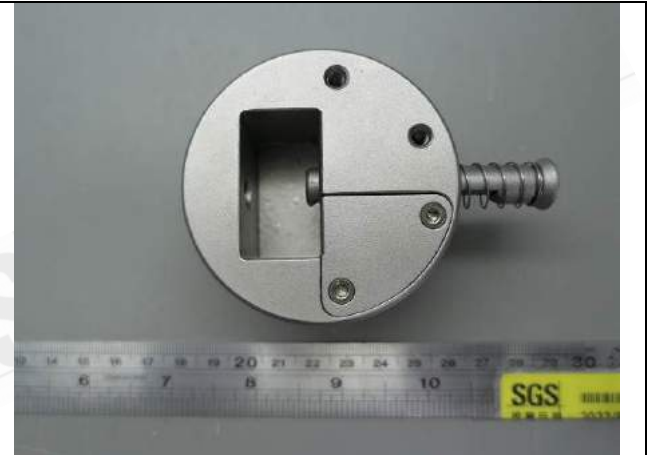
Photo "B" Appearance of sample (back view)

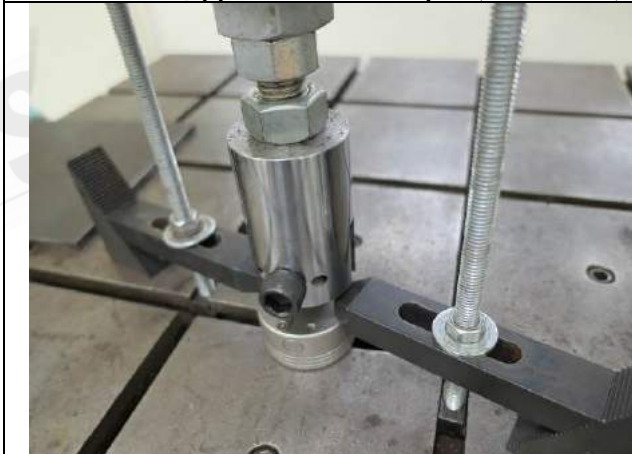
Photo "C" Test setup

- Fixed the sample on the platform. (Photo C)
- Apply an upward load to the sample until damage occurs to the sample.
- Record the maximum load and any findings.
- Test Rate: 10.0 mm/min.

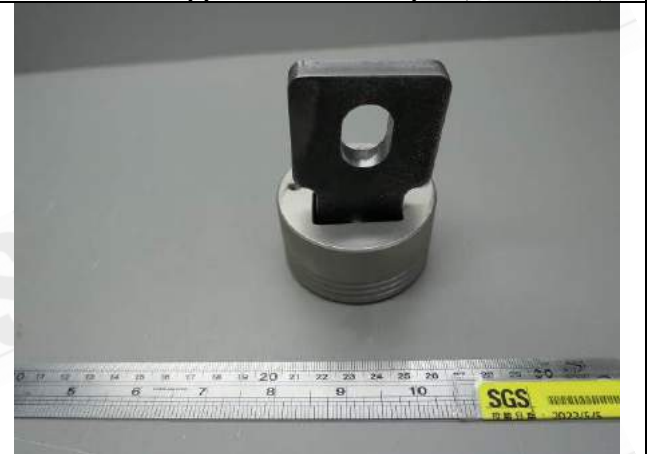
Photo "D" After test

Sample	Maximum force (kgf)	Test Result
01	2012.0	The sample is deformed and the key cannot open (Photo D)
